The Stations of the Tyne Valley Line

A review of the buildings, facilities and environment at the stations on the Tyne Valley Line, carried out on behalf of the Tyne Valley Community Rail Partnership (TVCRP)

October 2022

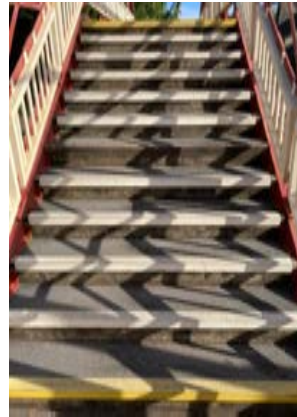
A missing anti-slip stair nosing on the footbridge at Wetheral was reported following the visit on the 8th August 2021 - ref 92099.

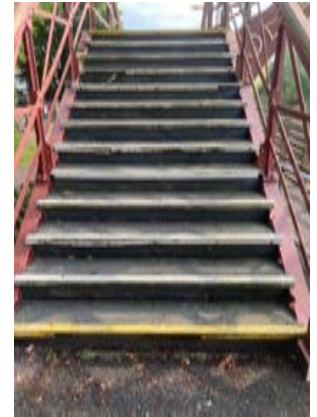
Broken timber stair nosings on the footbridge at Brampton were reported following the visit on the 15th August 2021 - ref 92521.

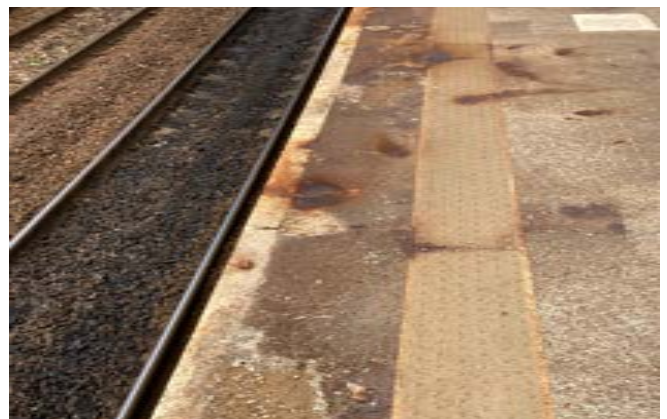
Potential trip hazards on Platform 1 at the Metrocentre and on the footbridge at Blaydon were reported on 27th July 2022. It is disappointing to note that the Blaydon fault was reported in the 2021 review and no action has been taken.

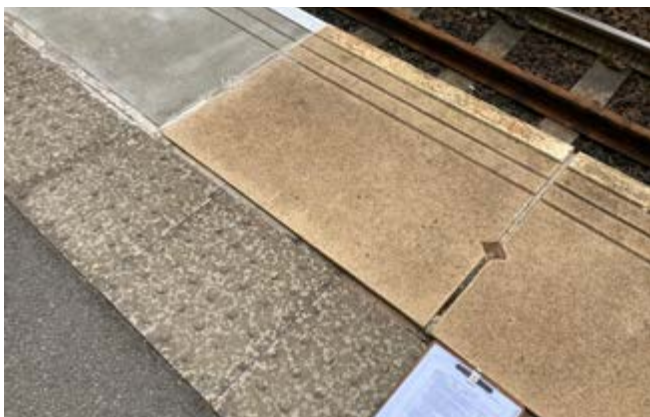
There is a lip between the tactile paving and the edge units on platform 1 at Wylam which may be considered to be a trip hazard and should be inspected as soon as possible.

9.Inspect and repair mortar joints between platform edge units and tactile pavings - locally on platform 2 and extensively on platform 1 (trip hazard)	ST

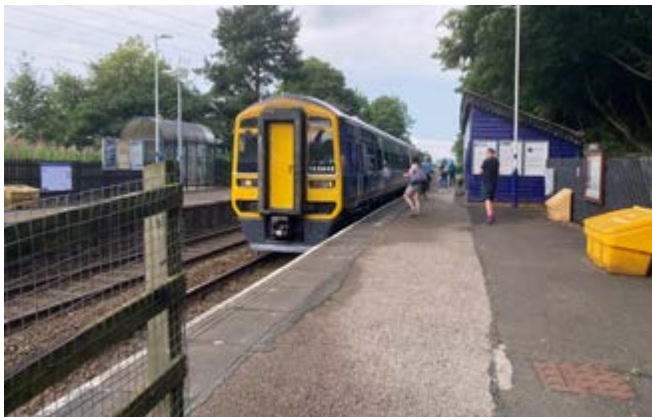
Lack of tactile paving

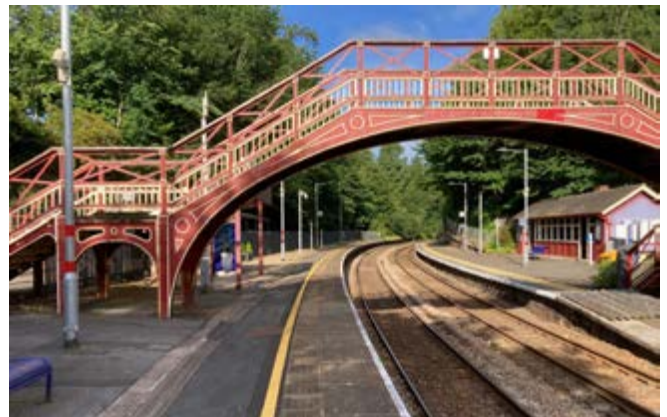
The yellow lines on the inner edges of tactile pavings, which are there to warn the partially sighted that they are approaching the platform edge are only in place at the mainline stations and at Wetheral.

Yellow line

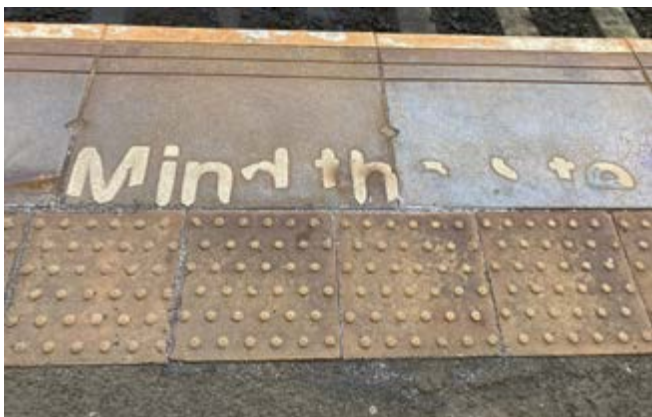
White line

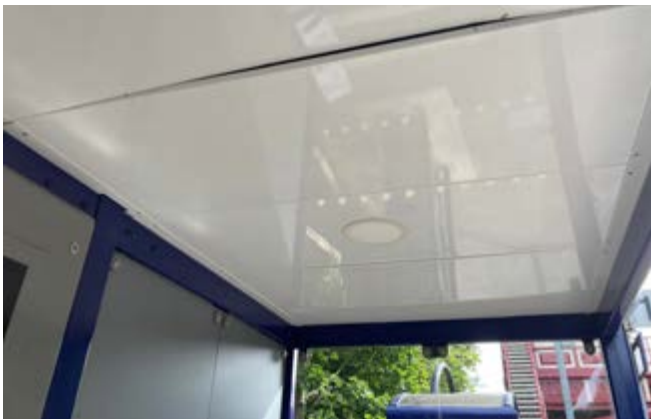
It is good to report that there is very little evidence of vandalism to the stations with virtually no graffiti. The damage to the ceiling of the platform 1 shelter at Wylam was the only notable item.

6.Main station signboard very faded - needs replacement	MT
7.Install car park lighting.	MT
8,Ceiling panel in platform 1 shelter pushed out of place - repair needed.	ST

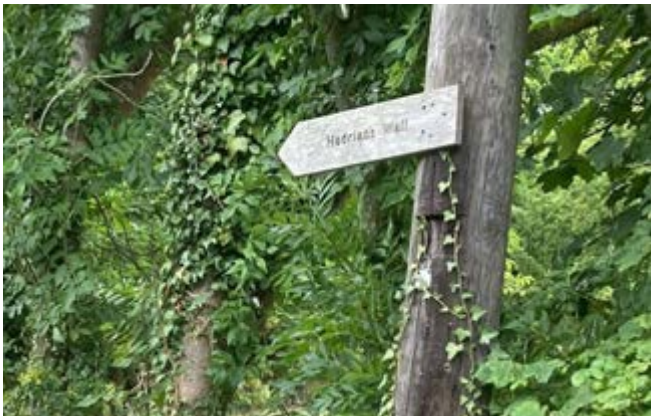
Bardon Mill

Signage in and around stations could be vastly improved, particularly with regard to signage to local points of interest and tourist destinations. A case in point is Bardon Mill, which is the station closest to Hadrian's Wall and the various attractions which form part of the World Heritage Site - and there is no adequate signage for the visitor.

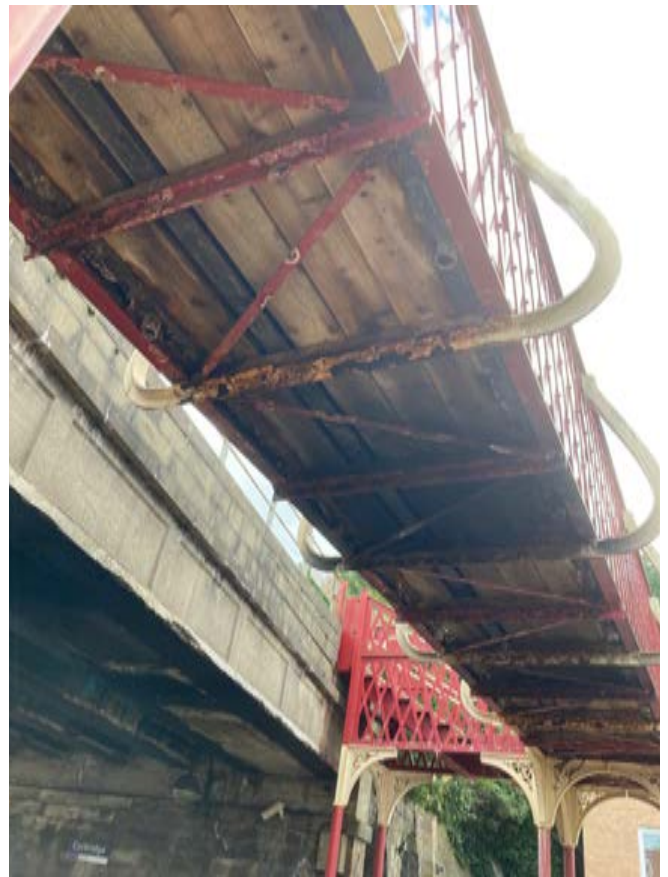
Many of the footbridges along the line are showing signs of corrosion to the steel structures. Corbridge appears to be in the worst condition but it is followed closely by the bridges at Wylam, Brampton, Hexham and Blaydon. The ramp access structure at Dunston is equally in need of treatment.

1. As mentioned in section 3.5 of this report, the steelwork to the footbridges is severely corroding. There should be a rolling programme of regular maintenance to these structures including the paintwork. It should be noted that the footbridge at Haltwhistle which has recently been re-painted is already showing signs of deterioration. Patches of paint are loosing their gloss and starting to exhibit a chalky appearance. The varnish on the hardwood handrail is also starting to flake off. This is also prevalent along the line e.g.Stocksfield.

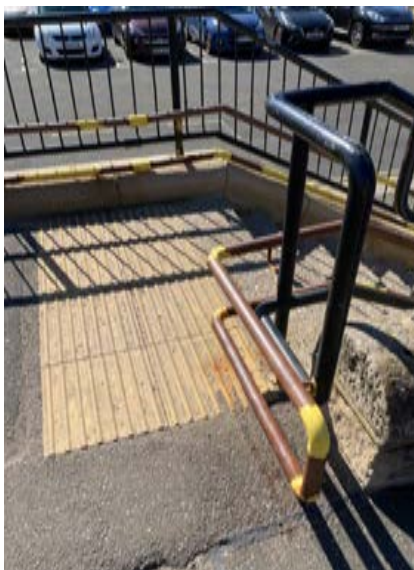
4. Handrails and guarding should be subject to a rolling programme of repainting. Particularly bad is the corroded state of handrails etc on the ramp from the car park and bus stop at Prudhoe up to platform 2.

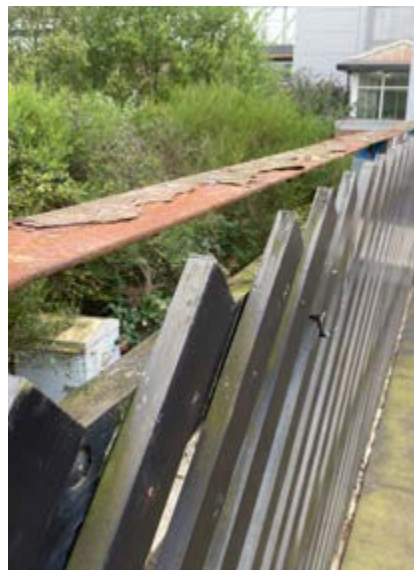
3. The paint/stain to the timber fences is in reasonable condition, but again, a rolling programme of painting should be instigated. The support steelwork to the fences at the Metrocentre is corroding badly and is distorted in places. This should be cleaned down and repainted.

8. Steel support to timber fence is rusting and bent - repaint	MT
9. Patch holes in concrete on platform 1 - trip hazard. Repaint lines to platform edges.	ST

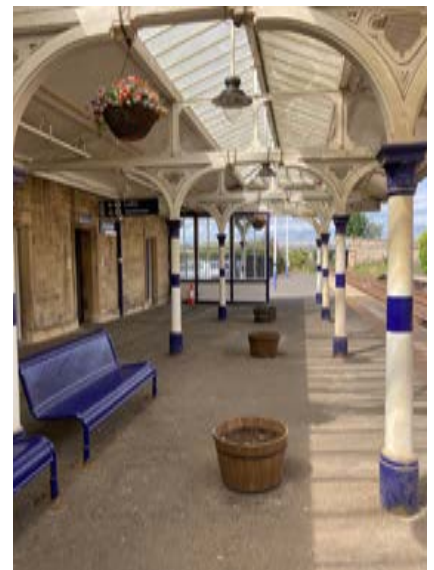
5. The metalwork and timber at Hexham is looking very down at heel and should be repainted as befits this flagship station.
6. The rooflights at Hexham and Corbridge are in desperate need of cleaning. It would dramatically improve the appearance and ambience of both stations by raising the levels of natural lighting on the platforms.

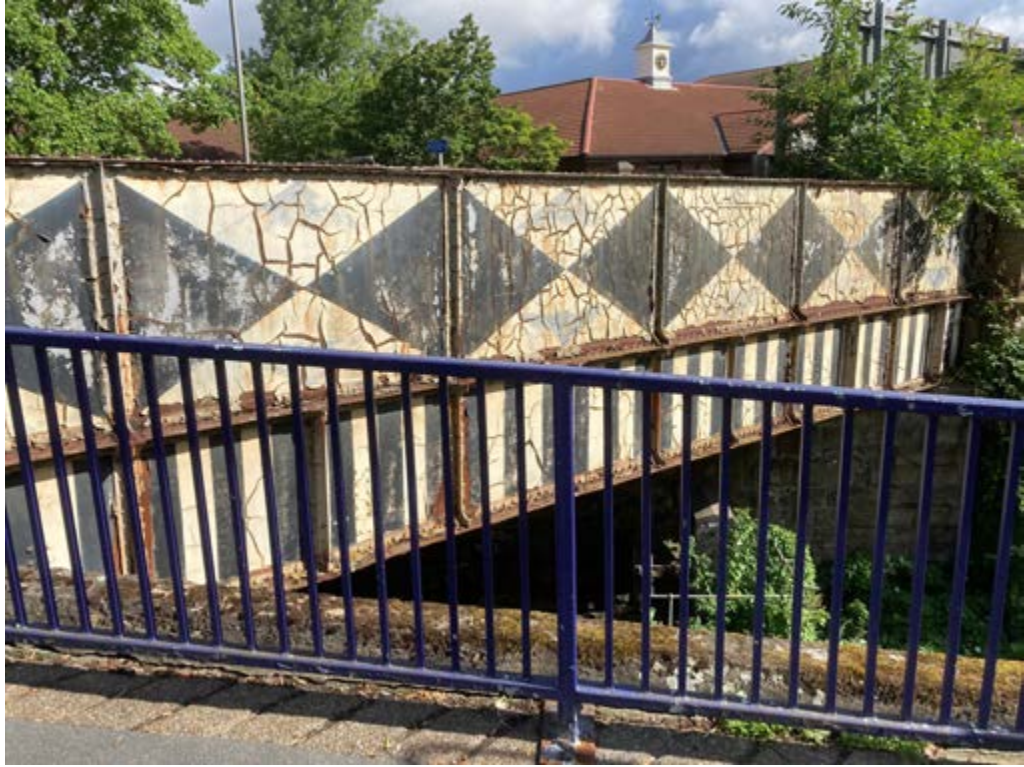
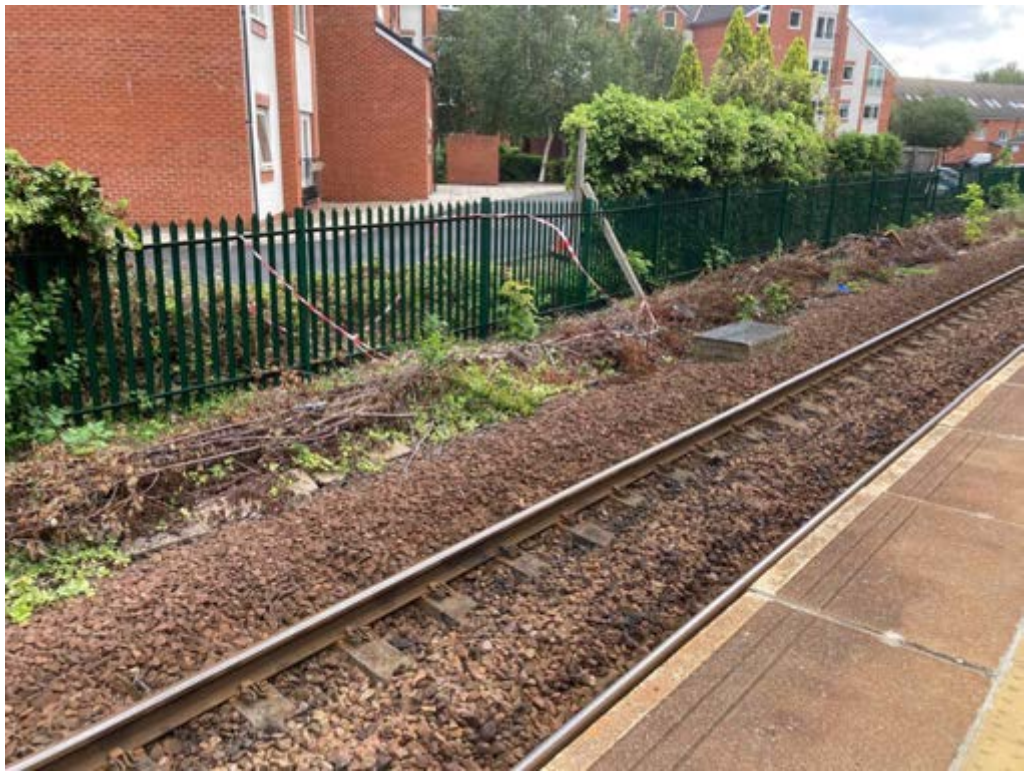
Station Name/Code: DUNSTON/DOT	SFO: Northern	
General ambience/state of repair/maintenance/cleanliness/graffiti etc		
1. While the station is clean and tidy and the CCTV cameras are operational, the single entry and exit point from the platforms gives a general feeling of insecurity. While the TVM has been twice vandalised in the past resulting in expensive repairs, it is working well with no recent problems.		
Environmental/planting/ecology/bio-diversity:		
1. There is an opportunity to introduce some planting either in planters (water supply would be an issue) or in the area at the foot of the ramp.		
2. Trees have been cut down and left opposite Platform 1 - unsightly.		
Photographs:

1. Re painting road bridge over station is needed (last painted for Garden Festival.)	MT
2. Replace existing ramped access to the island platform with a DDA compliant ramp and landings etc. (Existing ramp is over 40m long with only one landing. The steelwork is in generally poor condition and needs some attention.)	LT

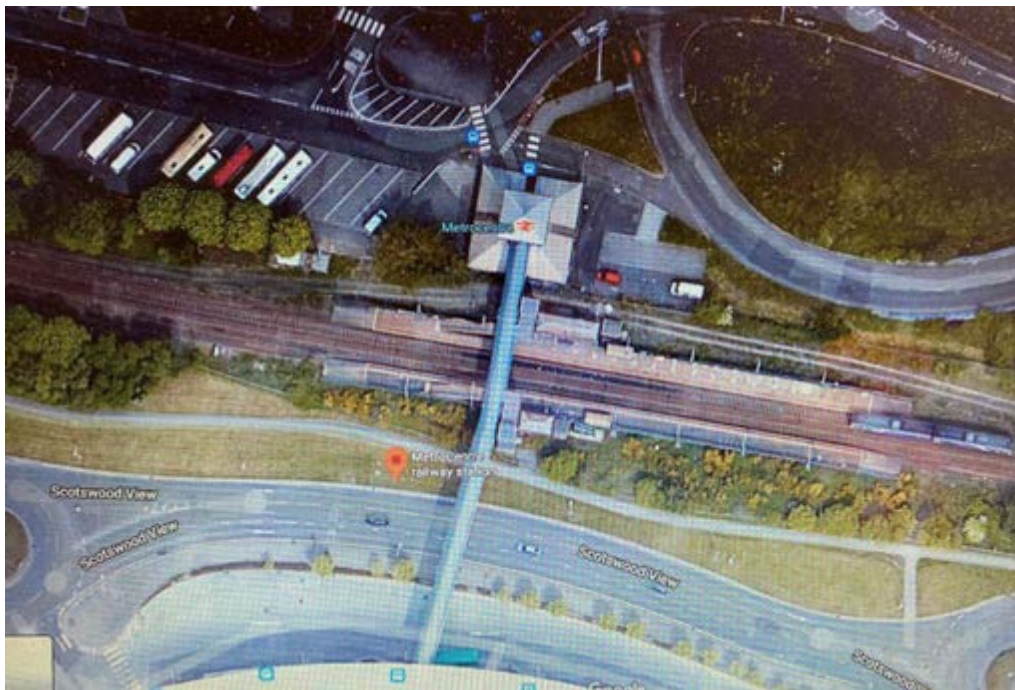
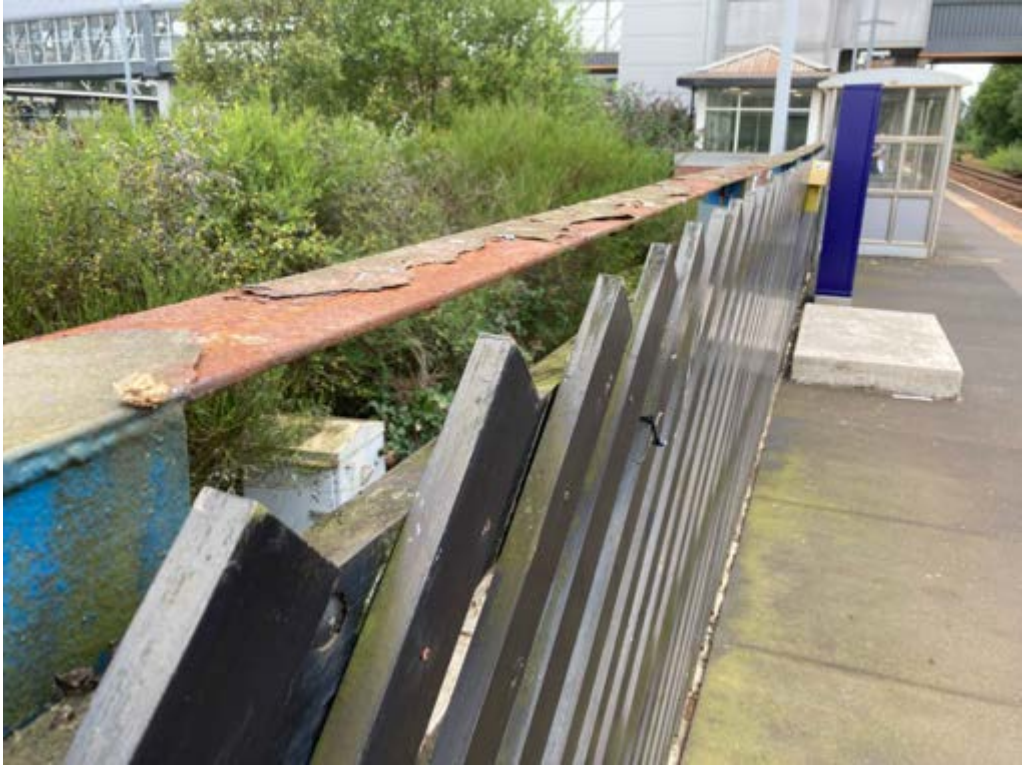
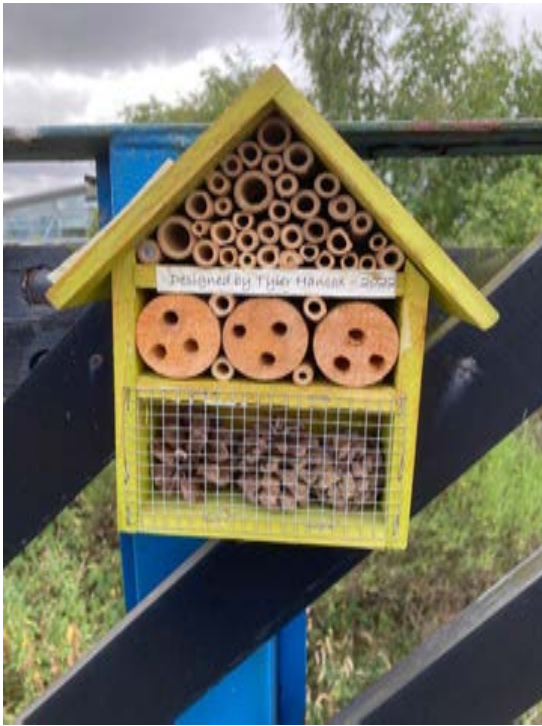
Station Name/Code: METROCENTRE/MCE	SFO: Northern		
General ambience/state of repair/maintenance/cleanliness/graffiti etc			
1. Generally very good. Repainting of platform access stairs needed			
2. Remove waste paper, cans and bottles from the waiting rooms and areas at bottom of lifts.			
Environmental/planting/ecology/bio-diversity:			
1. Opportunities for planting on platforms in free-standing planters, or on raised plinth under the stairs etc.			
2. The new insect hotels fixed to the fences are a delight.			
Photographs:

6. Review steep stair access from the coach park	LT
7. Concrete plinth by the TVM on platforms 1 and 2 are trip hazards. Complete installation of equipment or fit handrail protection.	ST

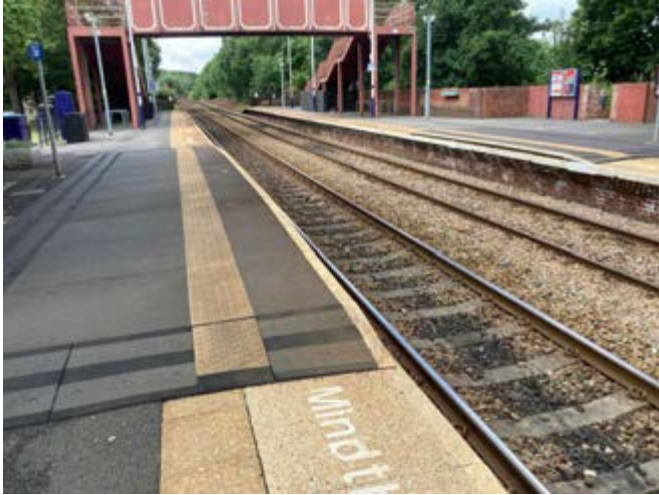
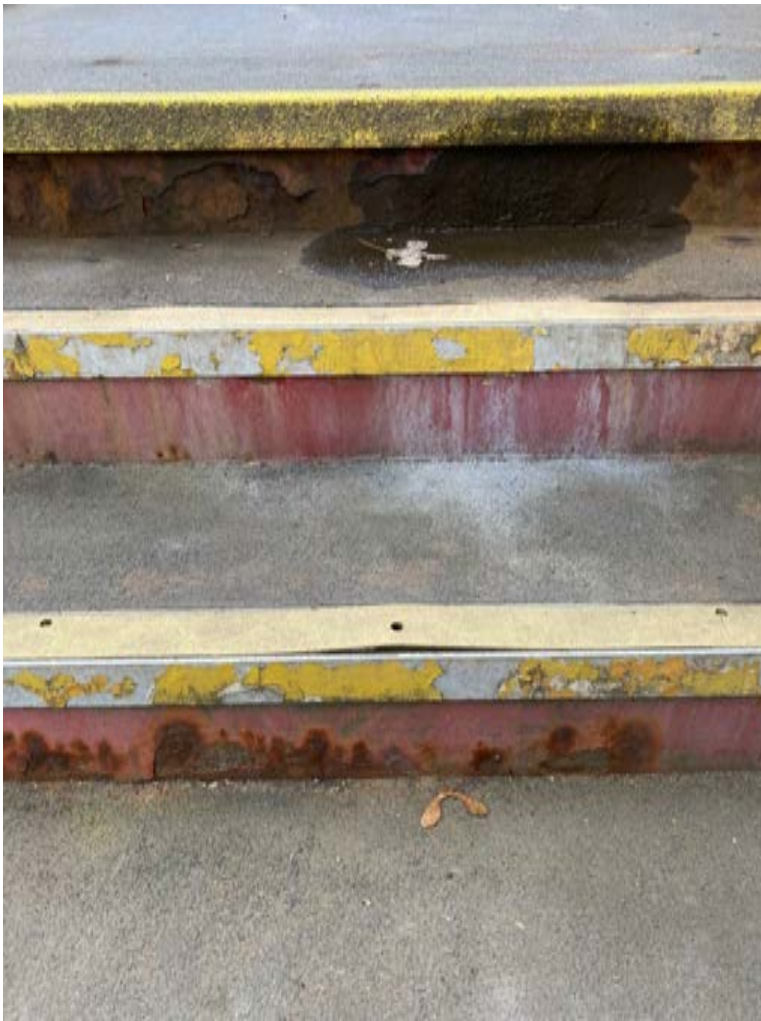
Station Name/Code: BLAYDON/BLO	SFO: Northern		
General ambience/state of repair/maintenance/cleanliness/graffiti etc			
1. Generally good but many large puddles form on the platforms, bridge and riverside walk during rain.			
2. Footbridge access to/from town centre not DDA compliant, the ramps being too long, steep and with too few landings.			
Environmental/planting/ecology/bio-diversity:			
1. Opportunity for more planters.			
Photographs

Specific proposals/actions resulting from the Audit	L/M/S Term
1.Paint and repairs to footbridge and railings	ST
2.Additional/more accessible car parking.	LT

9.Repair trip hazards on flooring and stair nosing to footbridge.	ST

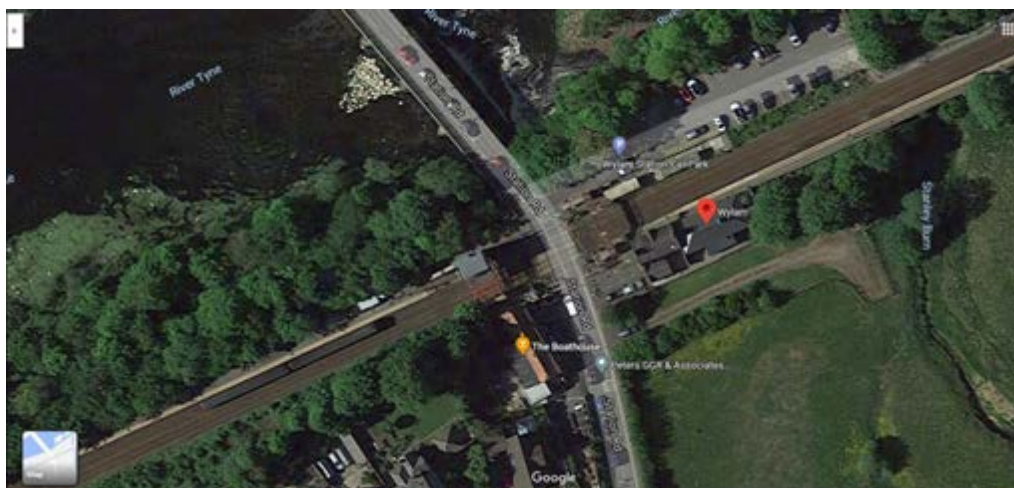
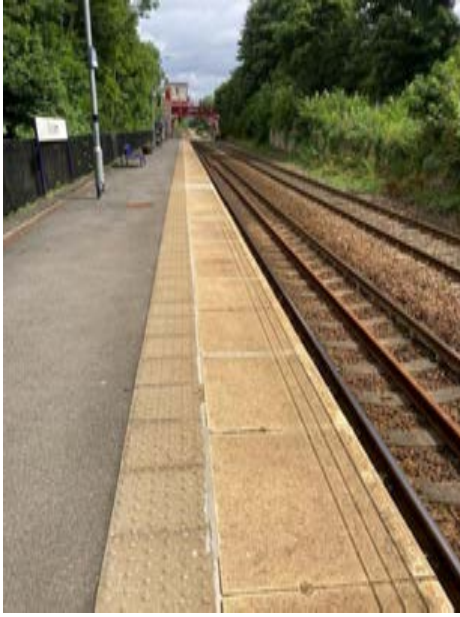
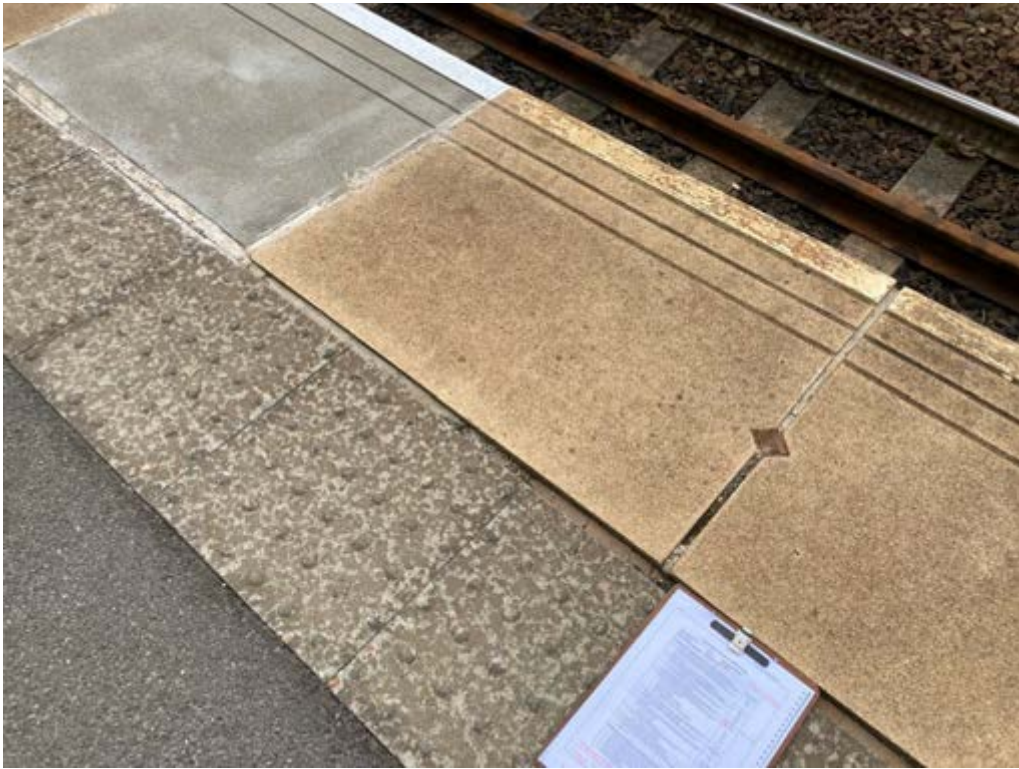
Station Name/Code: WYLAM/WYM	SFO: Northern	
General ambience/state of repair/maintenance/cleanliness/graffiti etc		
Generally very good. Some rubble and waste under footbridge could be tidied up. Paint metal railing on platform 1.		
There is some outward bowing to the dwarf wall to the rear of platform 2 which should be inspected regularly. Fit new stone copings to wall at east end of the station building.		
Environmental/planting/ecology/bio-diversity:		
Only one rectangular timber trough and four barrel planters on platform 1. Opportunities for improved planting.		
Photographs:

2.Connect/repair CIS in shelter on platform 1	ST
3.Car park markings to be re-painted.	ST
4. Re-paint footbridge.	MT
5.Re-paint edge of platform and signage 'Mind the Gap' etc.	ST

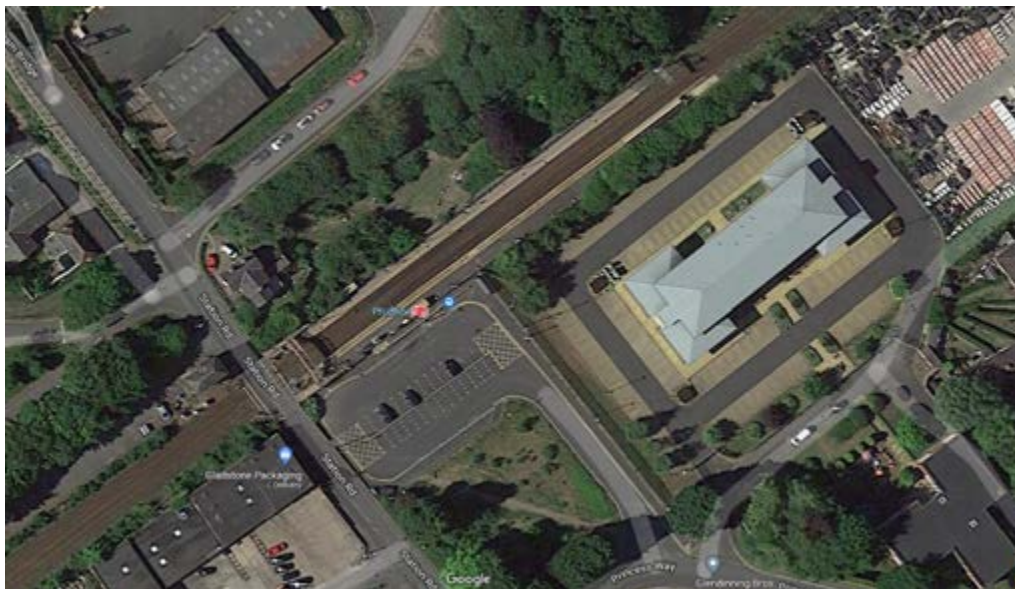
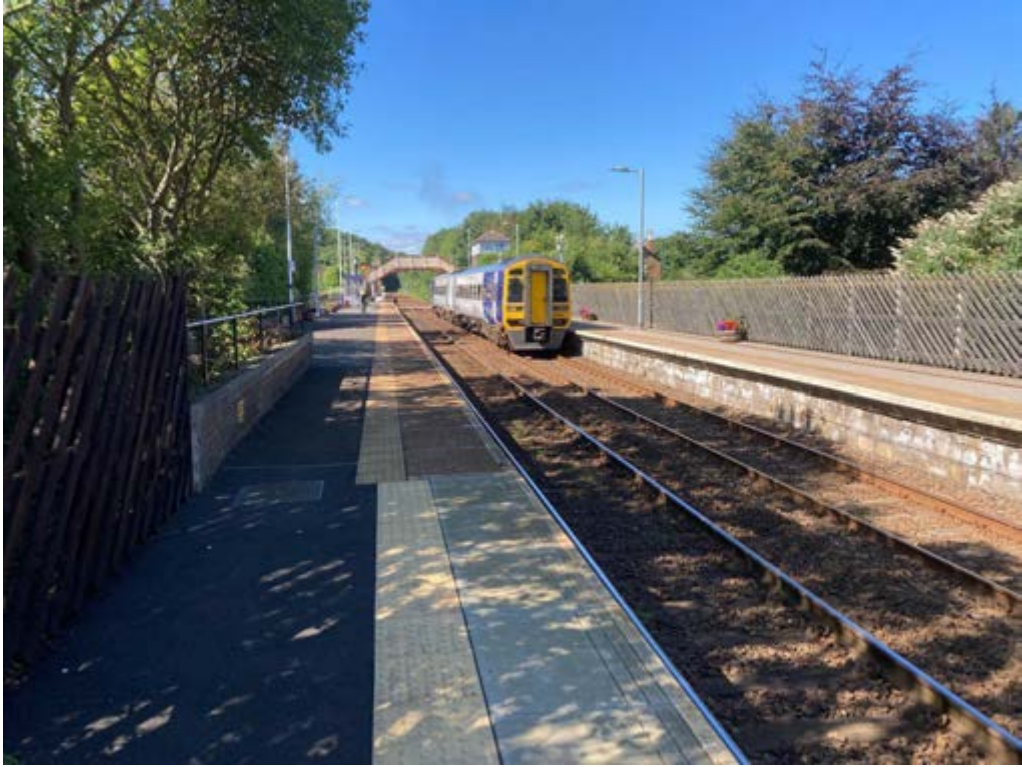
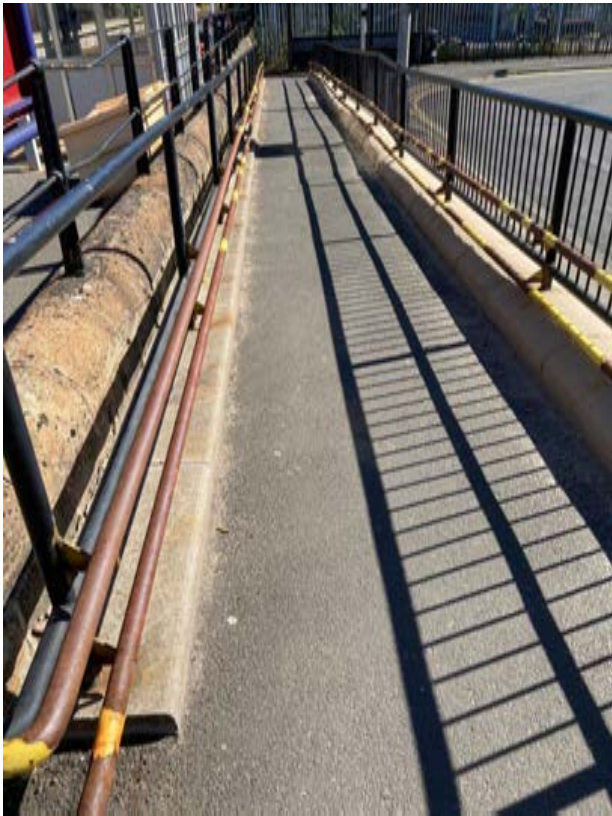
Station Name/Code: PRUDHOE/PRU	SFO: Northern	
General ambience/state of repair/maintenance/cleanliness/graffiti etc		
Generally very good as befits a transport interchange.		
Station is 'out on a limb', being distant from the town centre which is located up a steep hill.		
Environmental/planting/ecology/bio-diversity:		
7 planters to be replaced/augmented. Planting was very good and made a good show at the station.		
Explore the possible uses for the overgrown site adjacent to the main car park		
Photographs:

1.Re line car park adjacent to signal box	ST
2.Remove grit bins	ST
3.Remove remaining yellow coatings from buffer rails to ramps and repaint (NCC).	ST
4.Replace missing pedestrian gates at platform entrances off the road.	ST

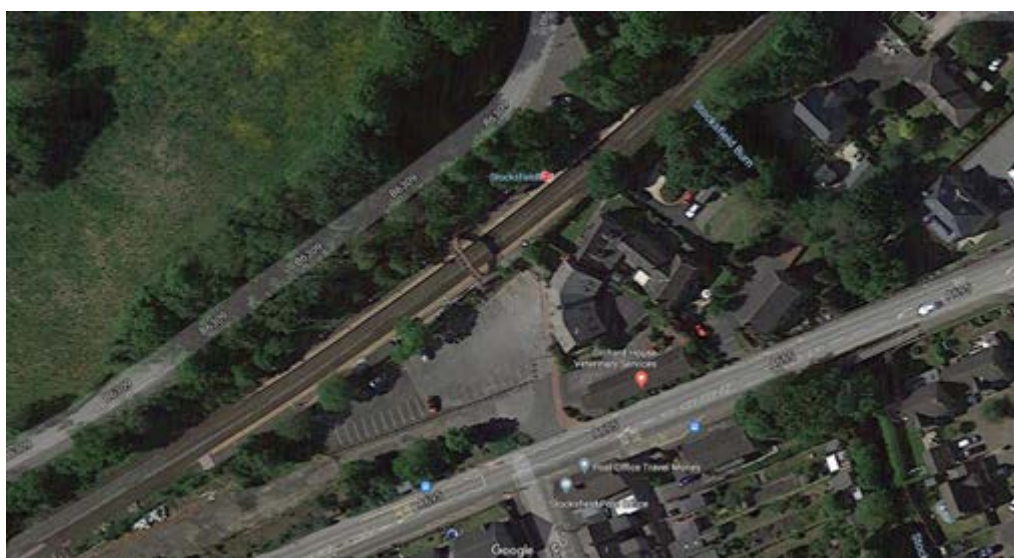
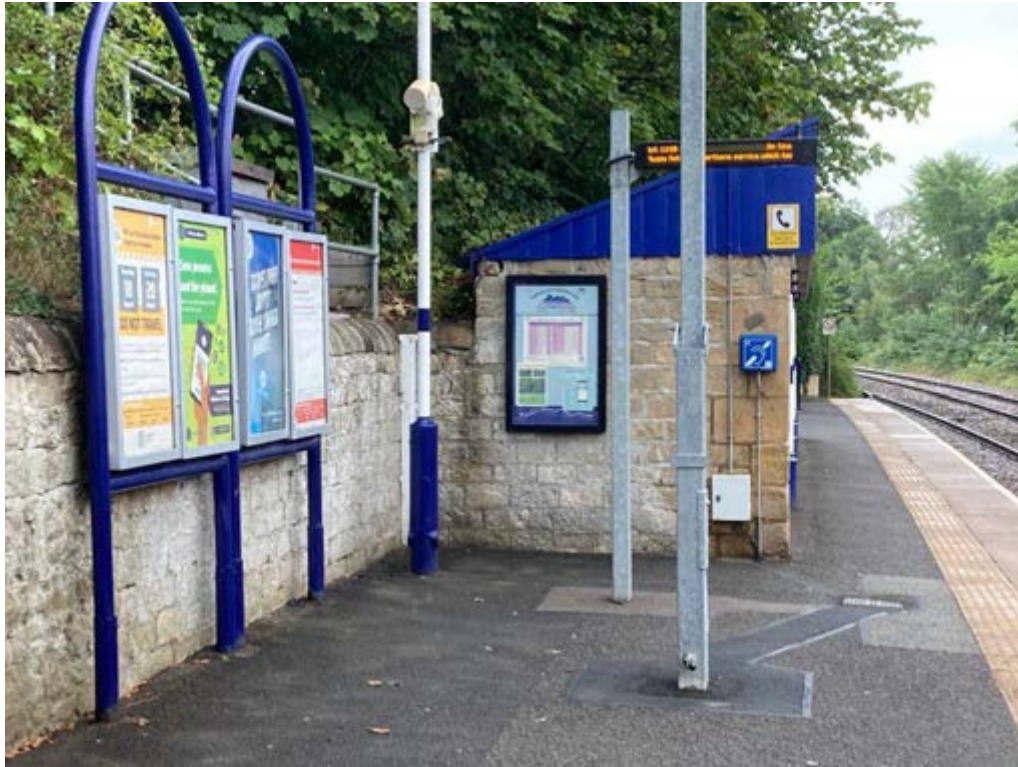
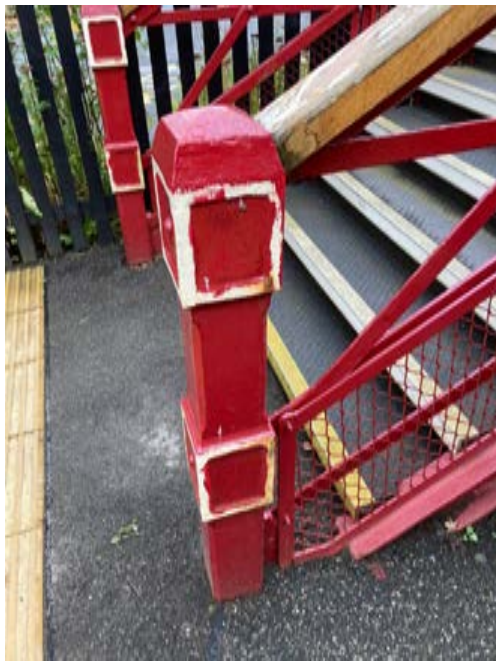
Station Name/Code: STOCKSFIELD/SKS	SFO: Northern		
General ambience/state of repair/maintenance/cleanliness/graffiti etc			
Generally good.			
The repainting of the footbridge should be completed and the varnish to the hardwood handrail to be removed as it is generally flaking off.			
Good signage for step-free route between platforms on P1.			
Environmental/planting/ecology/bio-diversity:			
Generally very good on this review. The planting on the bank to the rear of platform 1 is looking well maintained. Was this the work of local volunteers?			
Photographs:

1. Repair or replace the TVCRP notice board at entrance (left hand post rotten)	ST
2. Fit baffle to light on footbridge.	ST
3. Fit CCTV cameras to posts already in position.	MT

6. Clean or replace platform 2 number sign	ST
7. Trim bushes etc at the main entrance of car park to improve visibility.	ST
8. Fit gates to access road to prevent fly tipping/HGV parking.	MT

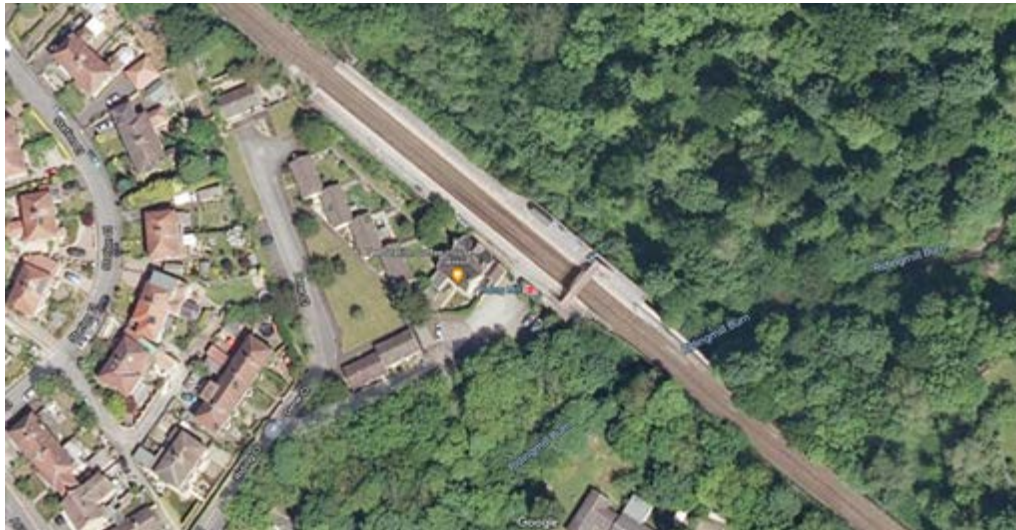
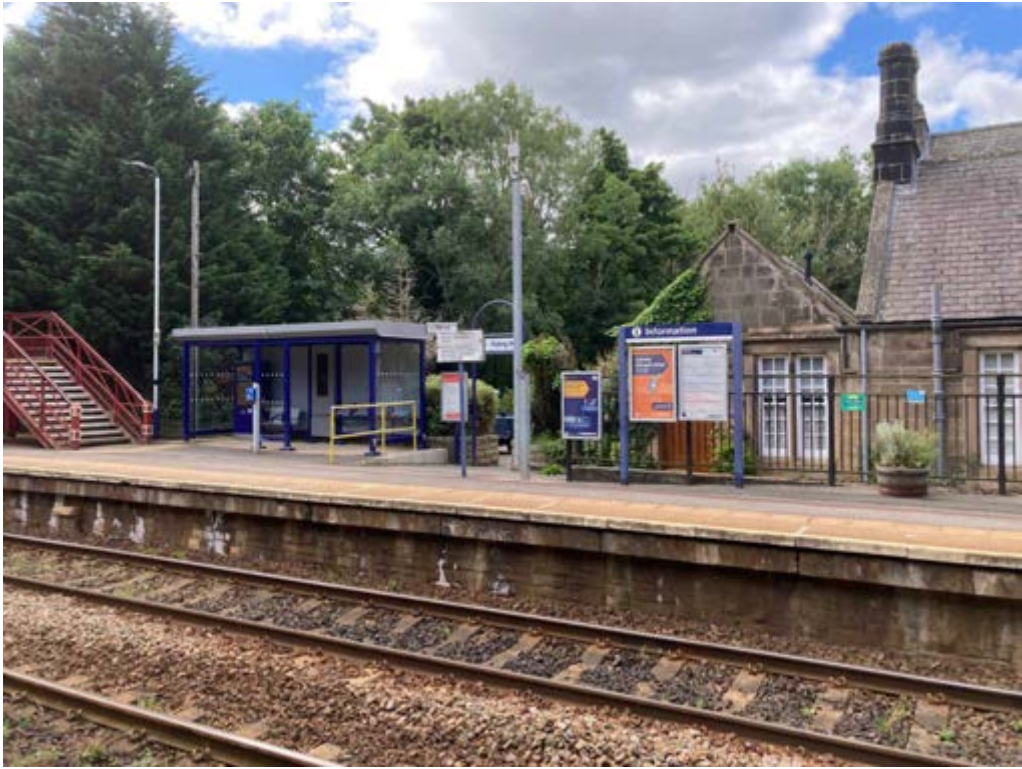
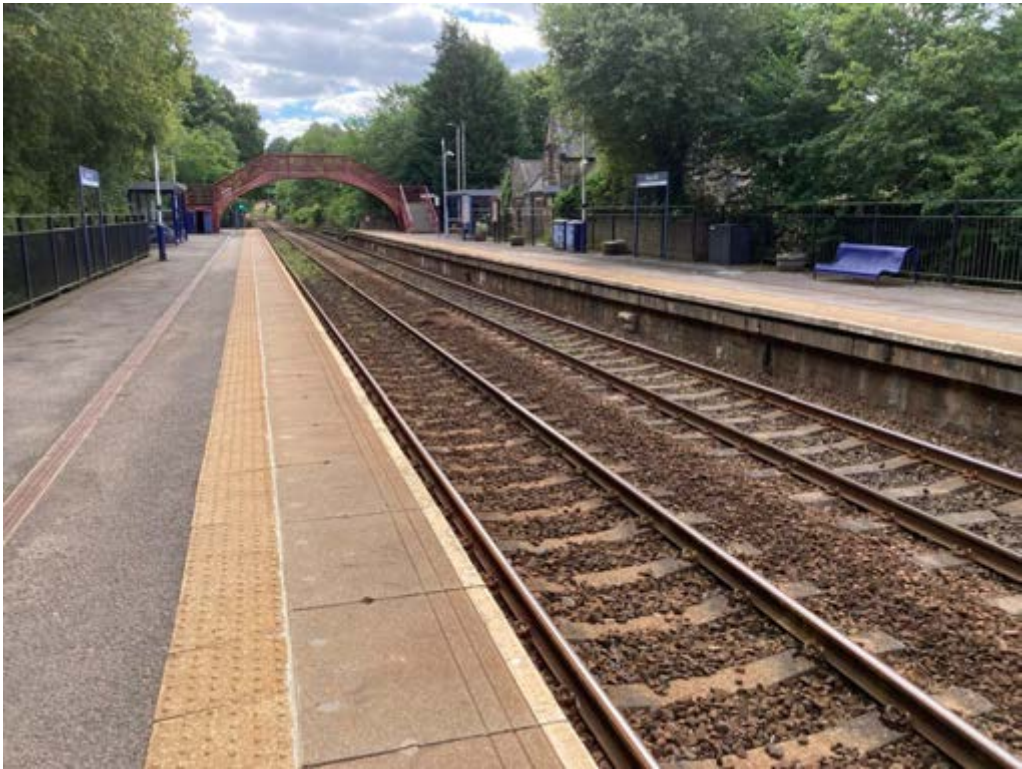
Station Name/Code: RIDING MILL/RDM	SFO: Northern		
General ambience/state of repair/maintenance/cleanliness/graffiti etc Generally good. Signs need cleaning.			
Environmental/planting/ecology/bio-diversity: Planters to be replaced and planted up			
Photographs:

3.Signs on platforms show available destinations but are old and should be replaced.	ST
4.Wayfinding beyond the station is incomplete. There is no sign from the A695 to the level access route to platform 1.	ST

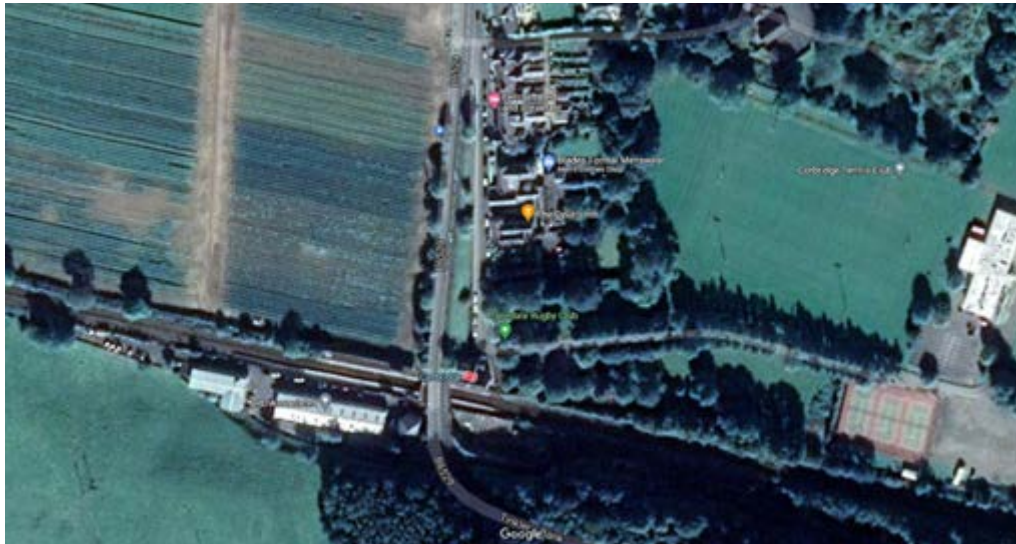
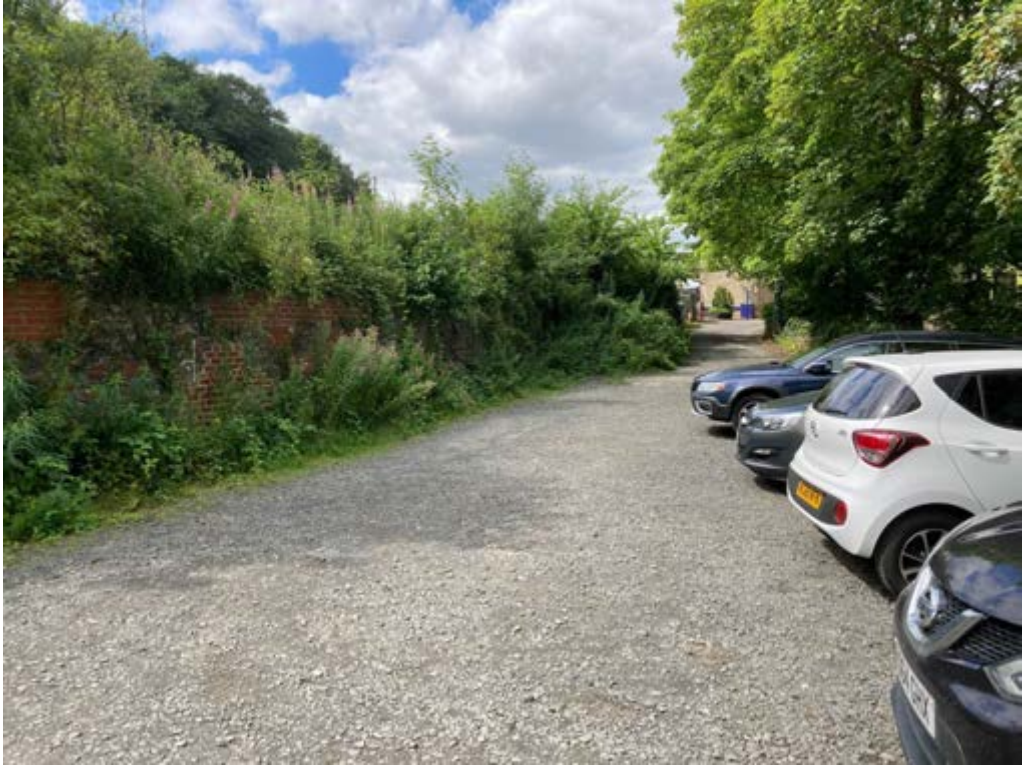
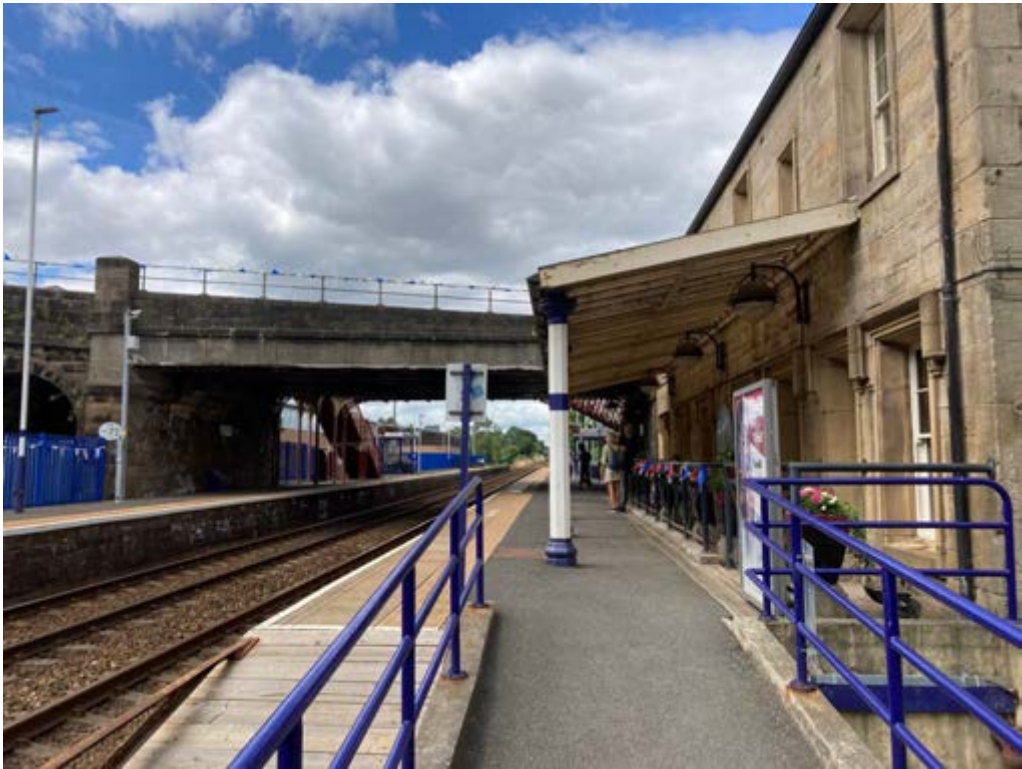
Station Name/Code: CORBRIDGE/CBR	SFO: Northern		
General ambience/state of repair/maintenance/cleanliness/graffiti etc			
Generally good, but the poor state of repair of the footbridge needs to be addressed.			
Environmental/planting/ecology/bio-diversity:			
There are opportunities for improvements.			
Photographs:

6. Repair spalling concrete to road bridge over station.	LT
7. Re-open discussions with bus-operating companies to improve the connectivity of the station to Town Centre and the Roman Town.	S/MT

8. Steelwork to footbridge in need of repair and painting	ST
9. Cut back weeds and bushes encroaching on the car park	ST

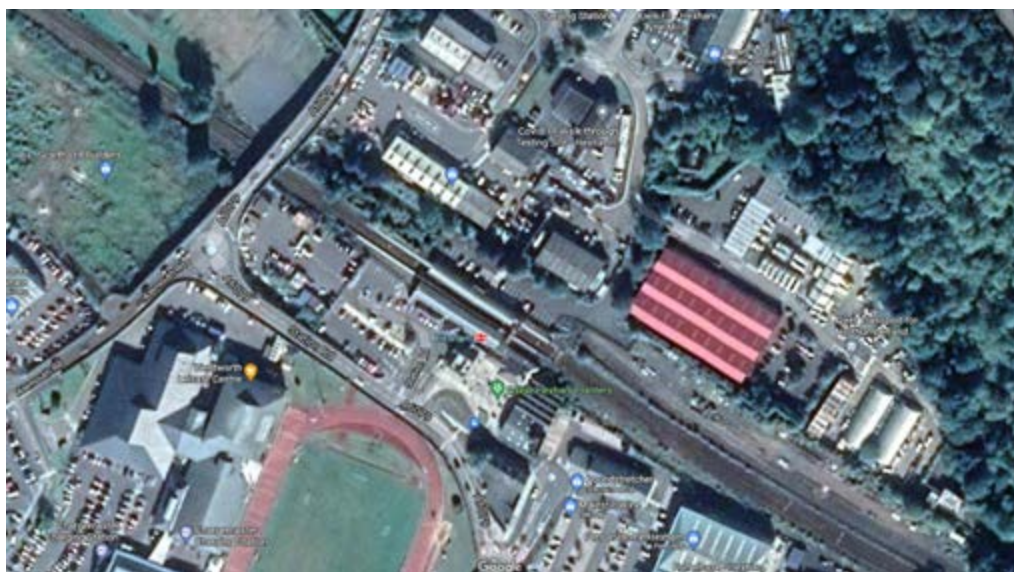
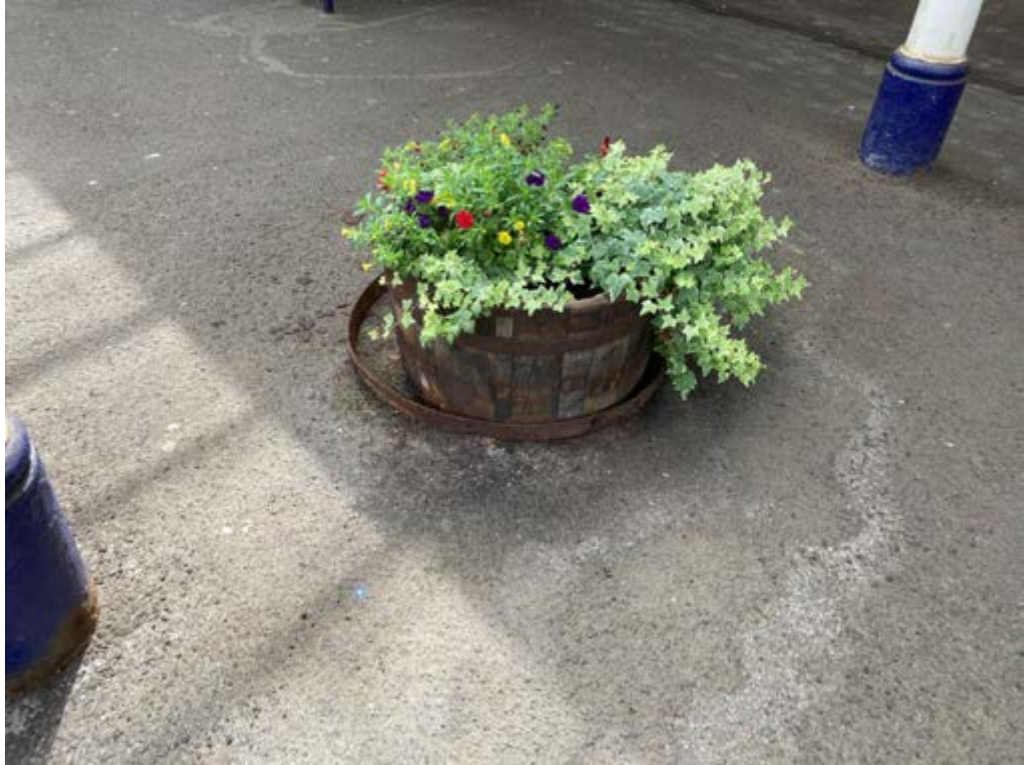
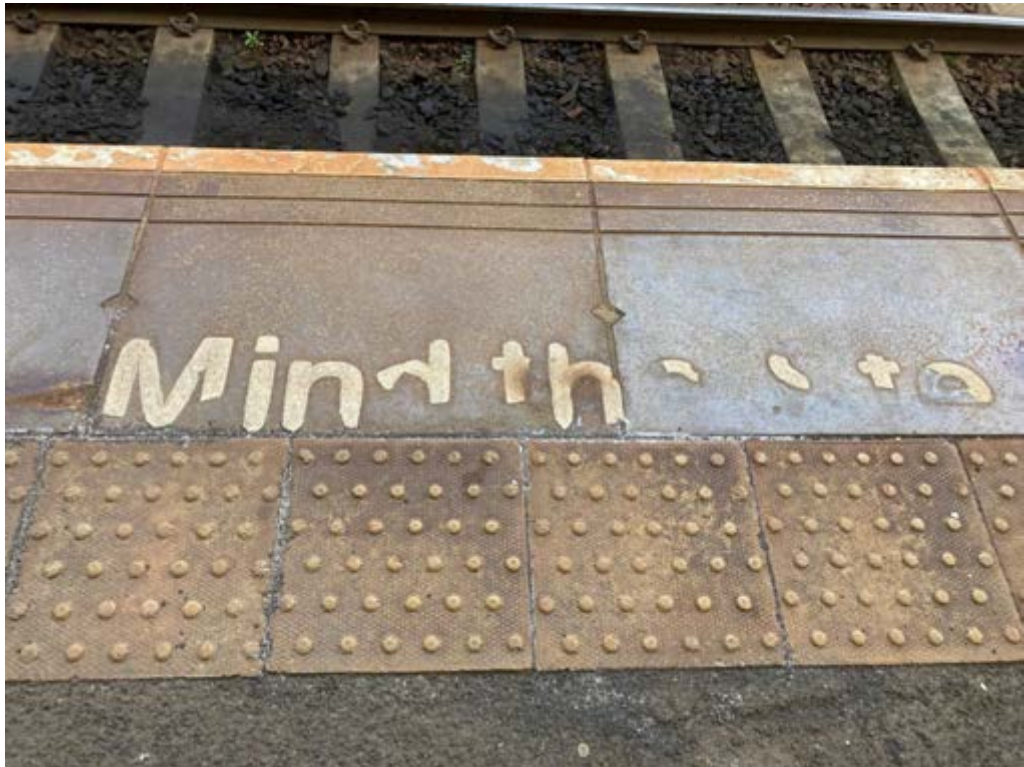
Station Name/Code: HEXHEM/HEX	SFO: Northern	
General ambience/state of repair/maintenance/cleanliness/graffiti etc		
Generally very good but the external stonework adjacent to the main entrance is in need of repair. The old water tower and Goods Shed (owned by the Arch Co.) are in serious need of repair.		
Cleaning the rooflights over the platforms would improve the appearance and lighting levels.		
Environmental/planting/ecology/bio-diversity:		
Generally very good but there are more opportunities for planting etc in the forecourt etc.		
Photographs:

Specific proposals/actions resulting from the Audit	L/M/S Term
1.Remove redundant vending machine on platform 1	ST
2.Replace broken planters.	ST
3.Repair gables to goods yard and complete repairs to the water tower.	MT

4.Repair paint and rusting structure to footbridge	MT
5.Clean rooflights and clean down and re-paint structure over platforms	ST/MT
6.Replace trees in existing planting area in station forecourt.	MT
