The Stations of the Tyne Valley Line

A review of the buildings, facilities and environment at the stations on the Tyne Valley Line, carried out on behalf of the Tyne Valley Community Rail Partnership (TVCRP)

October 2022

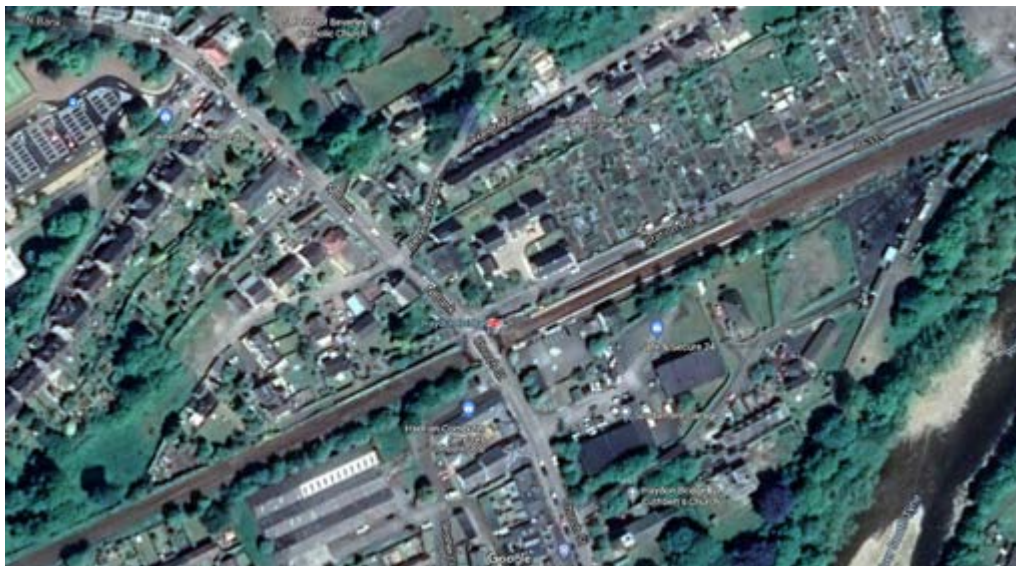
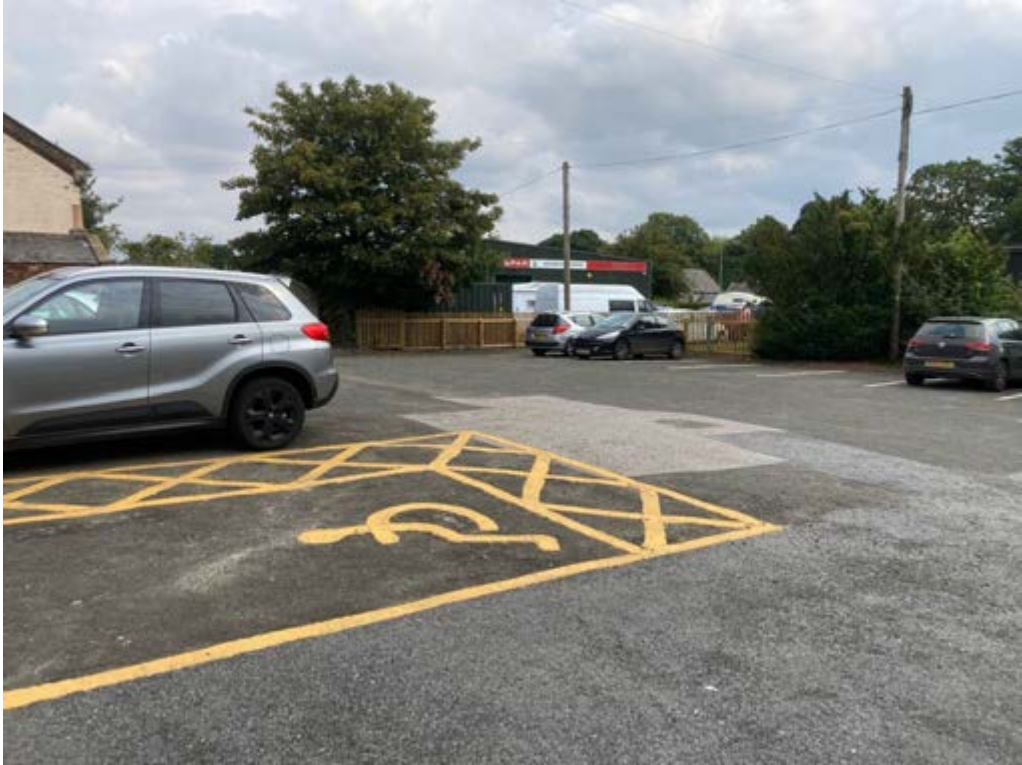
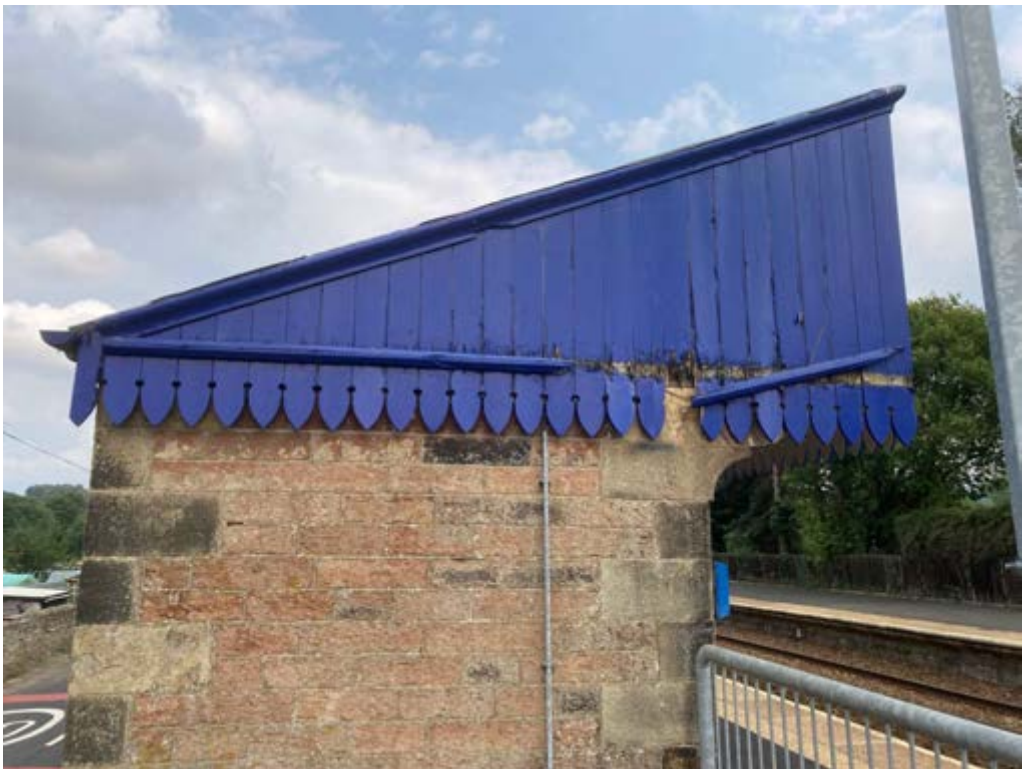
Station Name/Code: HAYDON BRIDGE/HDB	SFO: Northern		
General ambience/state of repair/maintenance/cleanliness/graffiti etc			
Generally very good			
The timber trims to the platform 1 shelter to be repaired and painted .			
The timber fence at the entrance to platform 2 needs to be painted.			
Environmental/planting/ecology/bio-diversity:			
Opportunity to improve planting to the back of platform 1 and the installation of a rain water butt beside the shelter.			
The blackberry bushes and apple trees to the back of platform 1 are carrying a lot of fruit and will encourage birds and other wildlife - More Please!			
Photographs:

8. Repair and repaint damage to the timberwork on the platform 1 shelter	ST
9.Stain fence on platform 2.	ST

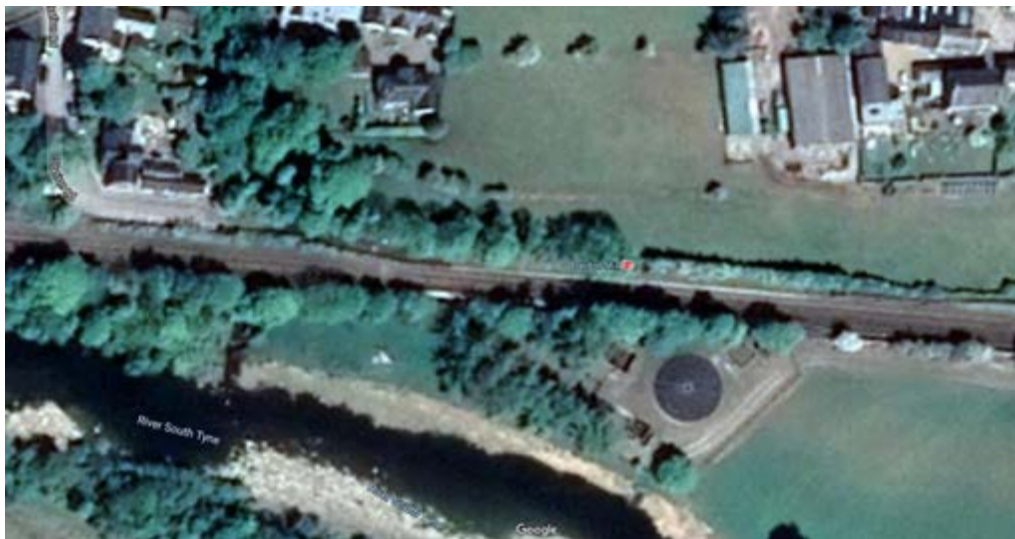
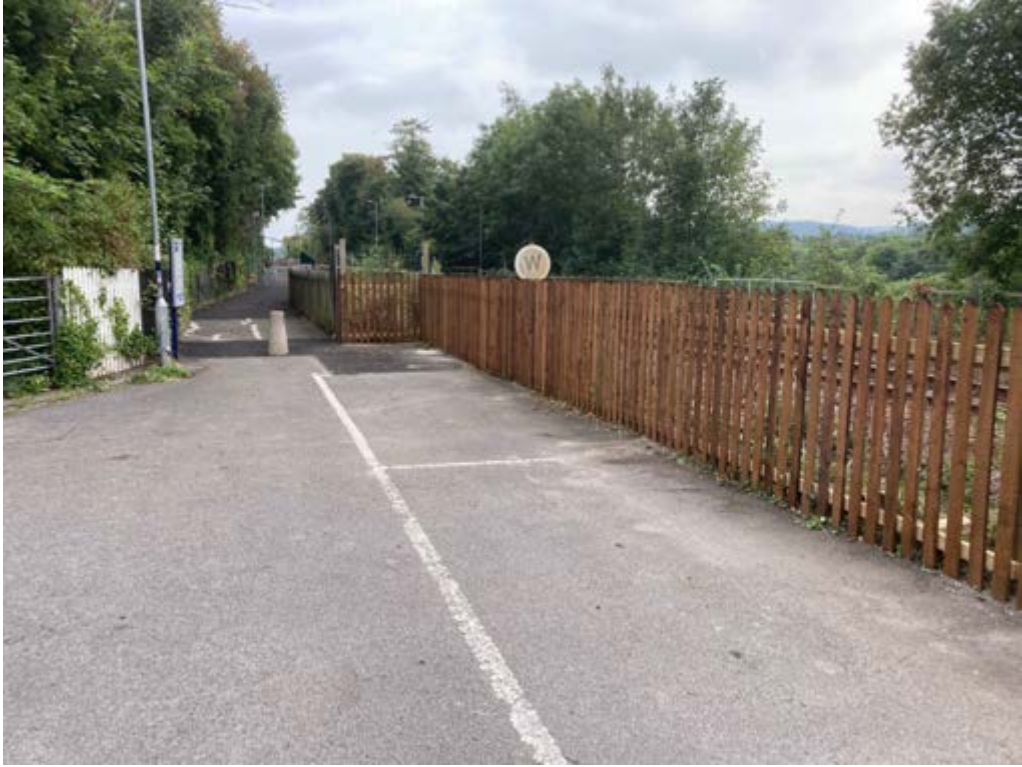
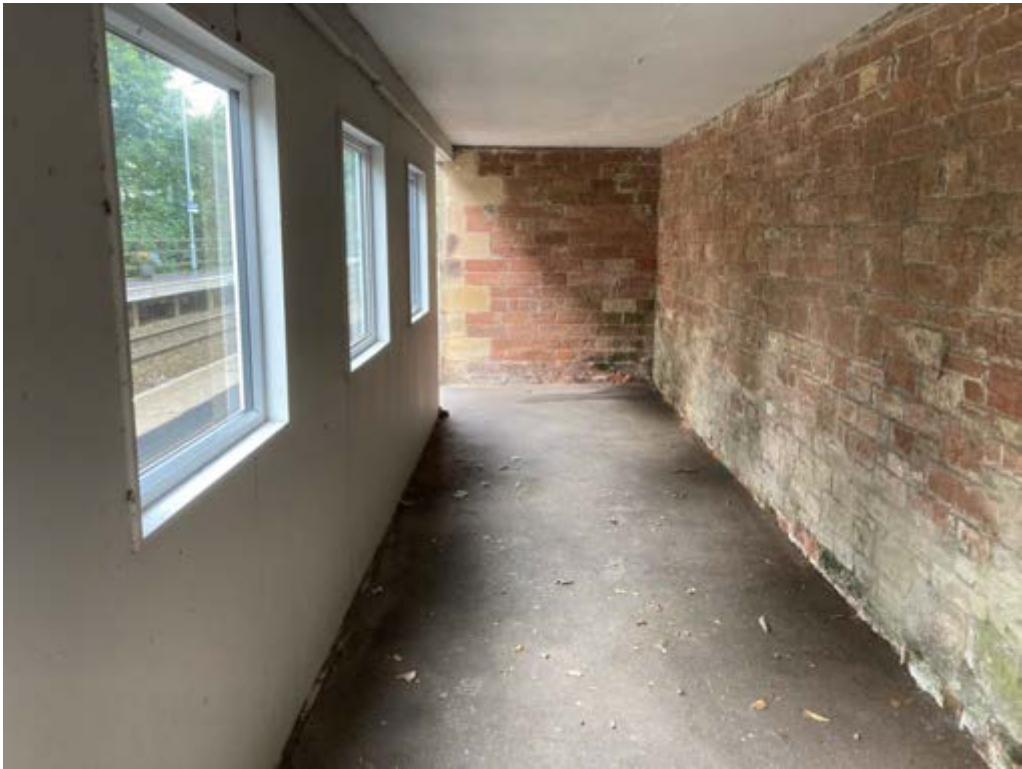
Station Name/Code: Bardon Mill/BLL	SFO: Northern		
General ambience/state of repair/maintenance/cleanliness/graffiti etc			
Generally very good.			
Unadopted station approach road in a poor state of repair with potholes etc Lighting is also poor.			
Signage generally could do with improvements, especially given the proximity to the World Heritage sites nearby.			
Environmental/planting/ecology/bio-diversity:			
Excellent planting in ceramic planters.			
Photographs:

8.Fit help point to platform 2.	ST
9.Replace rotten/missing fence and repaint. Re-stain fence to P2.	ST
10.Replace plastic glazing to roof of shelter on P2.	MT

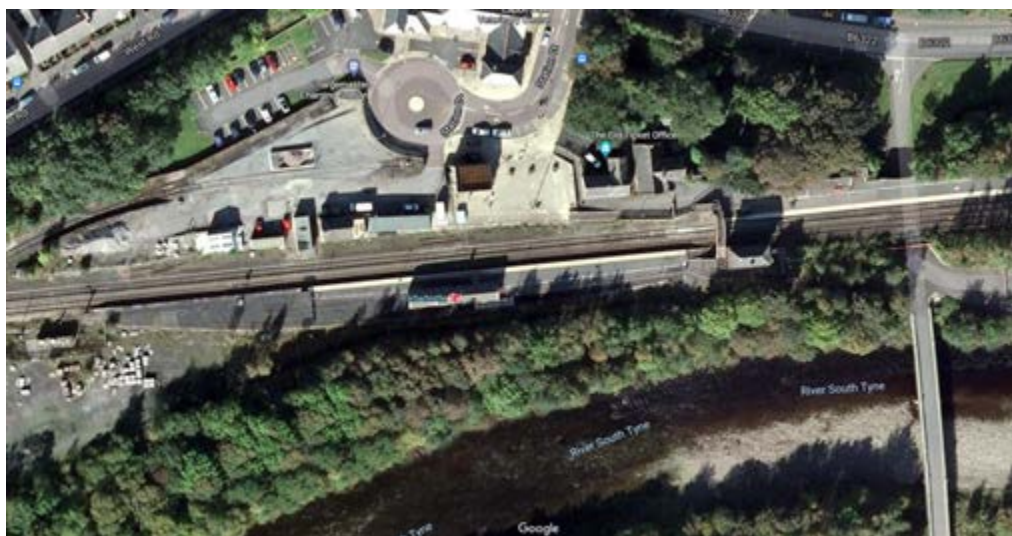
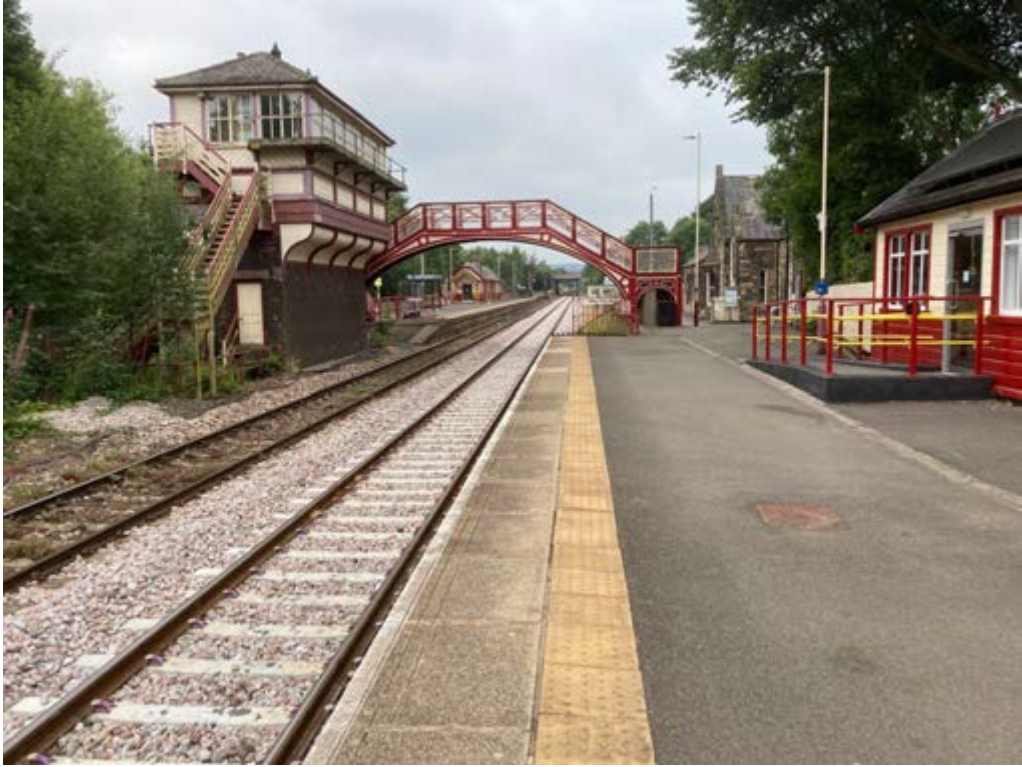
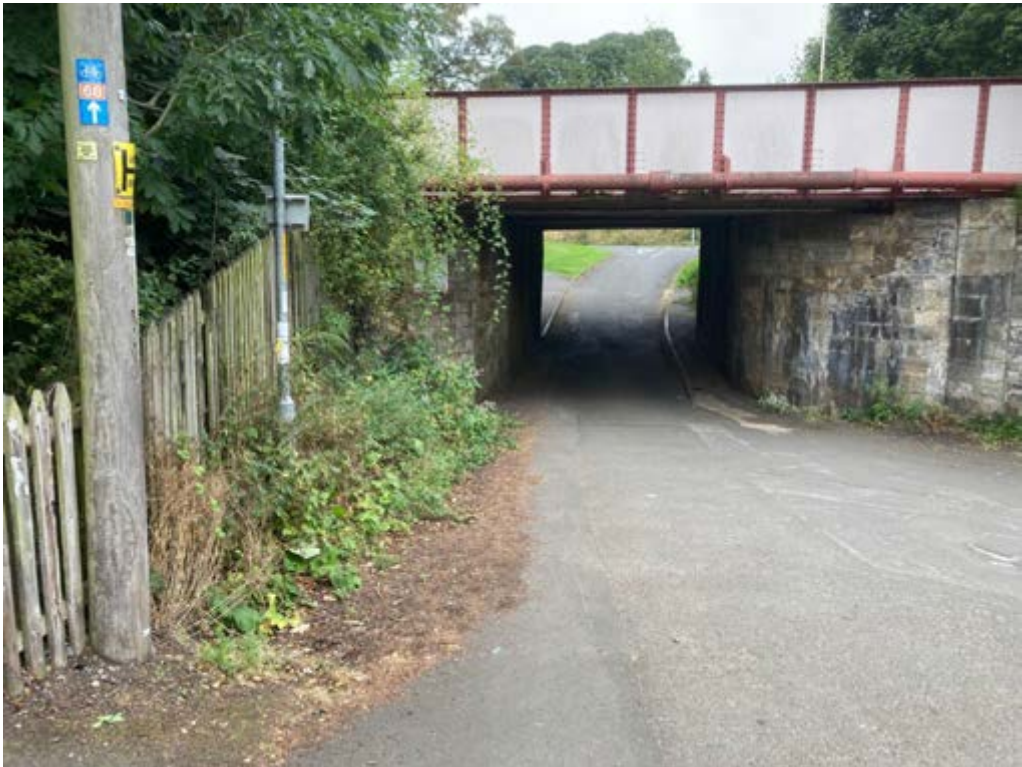
Station Name/Code: HALTWHISTLE/HWH	SFO: Northern		
General ambience/state of repair/maintenance/cleanliness/graffiti etc			
Generally very good. Underpass to platform 2 floods during heavy rainfall. Drainage to be improved.			
The Network Rail compound is very untidy. Installation of a fence or wall between it and the platform/water tower would improve the visual amenity of the station and improve the utility of the paved area in front of the water tower.			
Installation of a gate through the fence on platform 2 would improve links to the existing local footpaths.			
The varnish on the timber handrails on the footbridge is already flaking off.			
Environmental/planting/ecology/bio-diversity:			
Opportunity for significant improvements including planters on platforms, bird and bat boxes etc.			
Photographs:

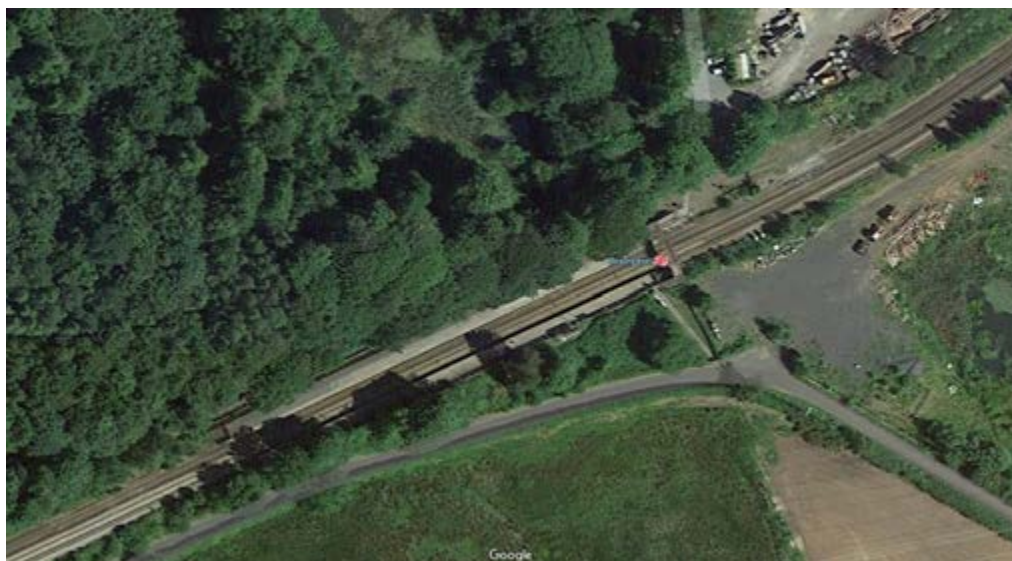
Photographs:

Station Name/Code: BRAMPTON/BMP	SFO: Northern		
General ambience/state of repair/maintenance/cleanliness/graffiti etc			
Generally good, but station is very remote from the town (half an hour walk).			
Buses should be provided and car parking provision improved.			
Fence to be re-stained.			
Timber trims to the stair nosings are generally rotten and falling off and could become trip hazards			
There is a prominent lip (up to about 20mm) behind the concrete edge unit to P2 forming a tripping hazard.			
Environmental/planting/ecology/bio-diversity:			
Plenty of opportunities here given its proximity to Talkin Tarn nature reserve.			
The two nests of House Martins in the shelter on P1 are no longer there. There are opportunities to install bird, bat and insect boxes at this station.			
More planters would improve the station appearance.			
The area inside the gate to the north is very unkempt and could be tidied up and planted to provide habitats for wildlife. The grassed area inside the South entrance could be treated similarly. The new fence there is welcome.

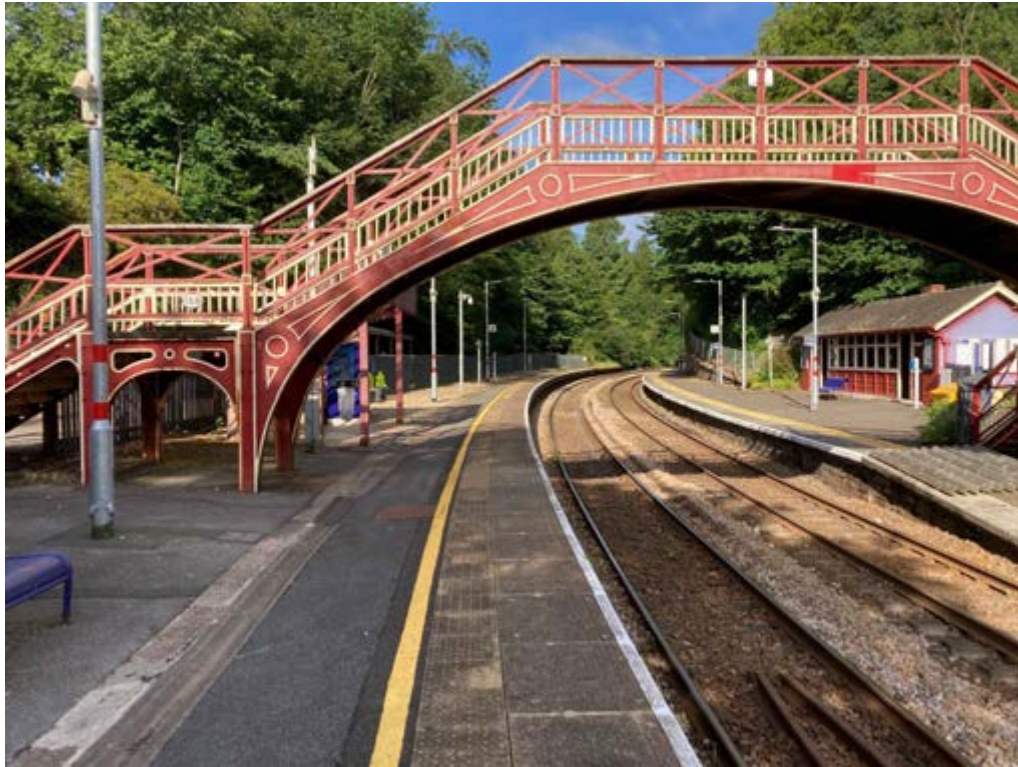
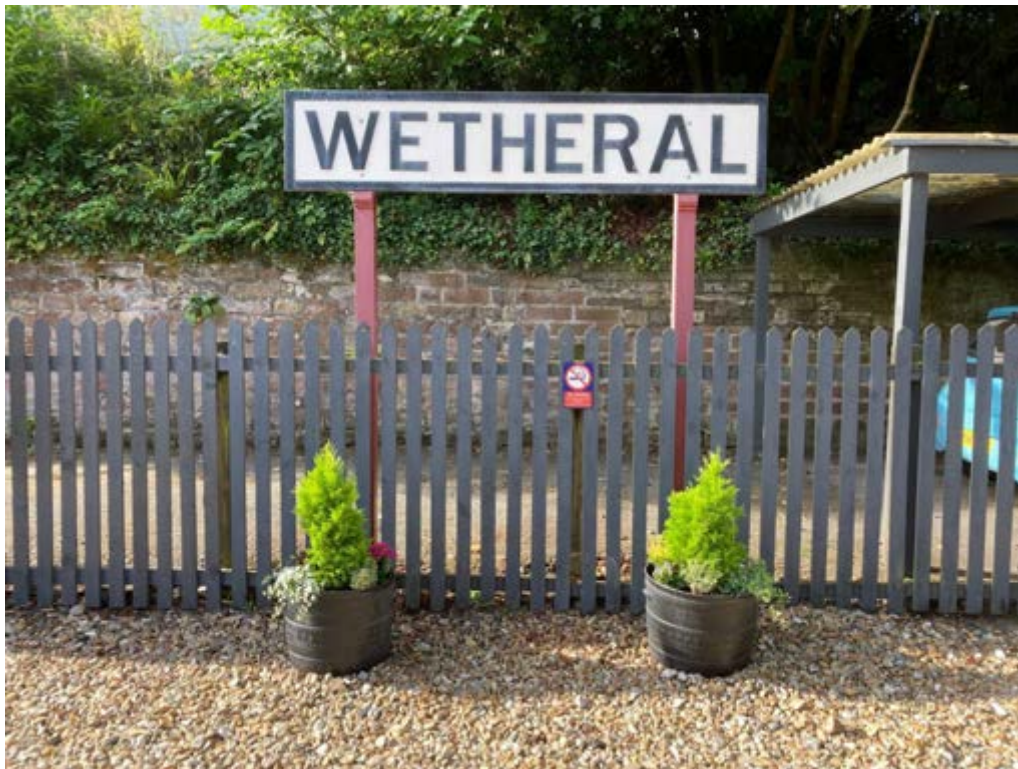
Station Name/Code: WETHERAL/WRL	SFO: Northern		
General ambience/state of repair/maintenance/cleanliness/graffiti etc			
Generally very good. Steelwork to the footbridge in need of repainting and the floor drain in front of the shelter on platform 2 needs to be cleaned out.			
The yellow safety line has been added to both platforms since 2021.			
A new CCTV camera has been well positioned on platform 2 to cover both entrances, the footbridge, viaduct and platforms. Is it operational yet?			
Environmental/planting/ecology/bio-diversity:			
Additional planting in the planting area on platform 1 and planters on the gravelled area on platform 2 would improve it enormously.			
Photographs:

10.Replace community notice board and add paving slab access to it.	MT
11.TVM is difficult to read when sun shines on the screen - create baffle	ST

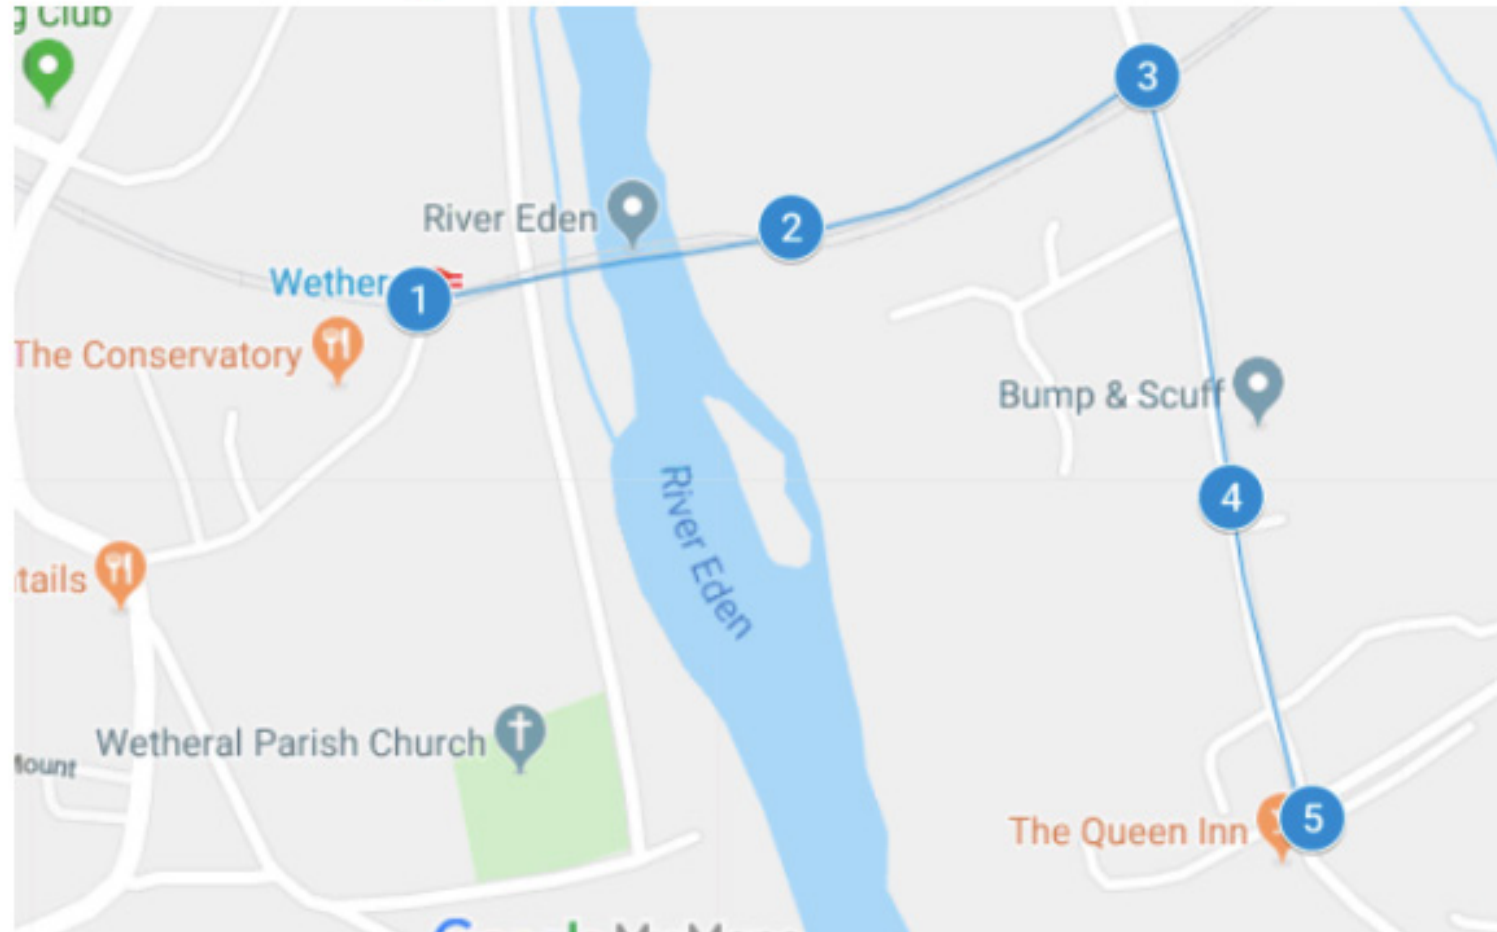
Map: Wetheral Route 2

Segment Directions: Wetheral Audit Route 2
